INDOOR AIR QUALITY ASSESSMENT

**Blackstone Town Hall
15 St. Paul Street
Blackstone, Massachusetts**

Prepared by:
Massachusetts Department of Public Health
Bureau of Environmental Health Assessment
Emergency Response/Indoor Air Quality Program
May 2003

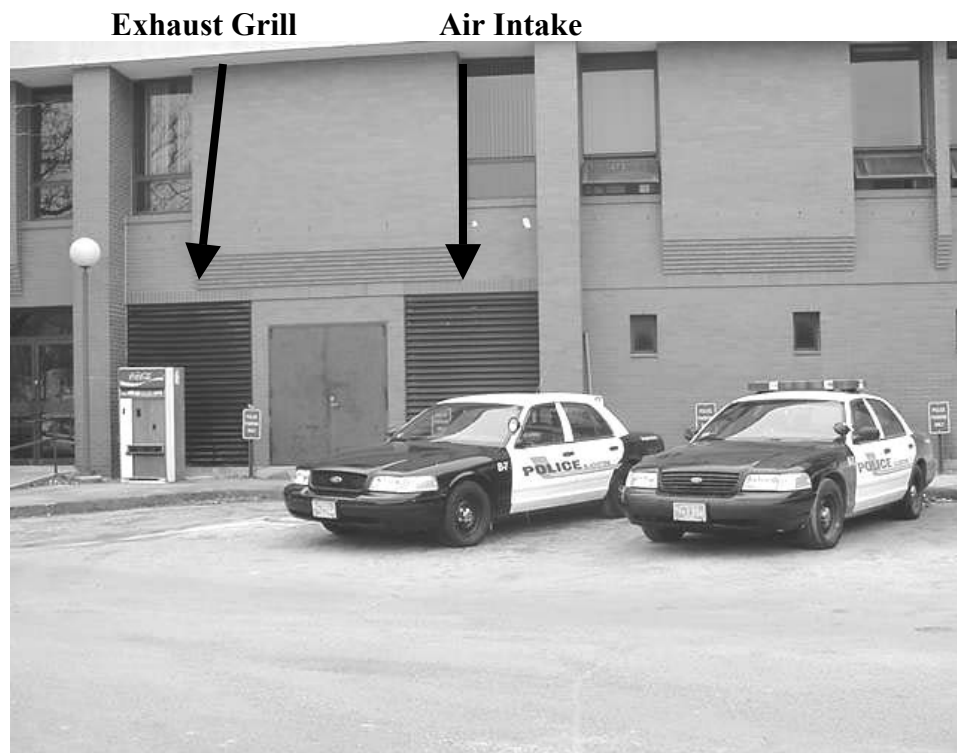
Picture 1

Ventilation is provided by a heating, ventilation and air-conditioning (HVAC) system. An air handling unit (AHU) located in a mechanical room on the ground floor provides fresh air for all areas within the BTH. The AHU draws air from the rear of the building through a large grate (see Picture 1). Air is then supplied to occupied areas by ceiling mounted air diffusers connected to the AHU via ductwork.

Return ventilation is provided by the AHU, which draws air through ceiling-mounted exhaust grilles via ducts. The exhaust for the AHU exits through a vent at the rear of the building, next to the fresh air intake (see Picture 1). Draw of air by return vents was weak in some areas. Without proper exhaust ventilation, normally occurring environmental pollutants can build up and lead to indoor air quality complaints.

Several other conditions, which can affect indoor air quality, were noted during the assessment. Building occupants report periodic odors of fuel exhaust in the BTH. The design of the building and its location related to the parking lot (see Figure 1/Picture 1) make it possible for vehicle exhaust emissions to be entrained by the AHU. Certain wind and weather conditions can foster the entrainment of these exhaust emissions into the building through the AHU. The process of combustion produces a number of pollutants, depending on the composition of the material. In general, common combustion emissions can include carbon monoxide, carbon dioxide, water vapor and smoke. Of these materials, carbon monoxide can produce immediate, acute health effects upon exposure. Measurable levels of carbon monoxide slightly above background were detected in the building (see Table 1).

Air Intake Grill on Rear of Building, Note Proximity of Vehicle Parking

1. Consider installing an automatic control to activate the engine bay exhaust system as engine bay doors open. Examine the feasibility of connecting this system to the exhaust vent in the fire pole access room.
2. Consider the feasibility of relocating the vehicle parking area further away from outside air intakes to avoid the entrainment of vehicle exhausts. If not possible, consider contacting an HVAC engineering firm to examine alternative options (e.g. installing ductwork to draw from roof level).

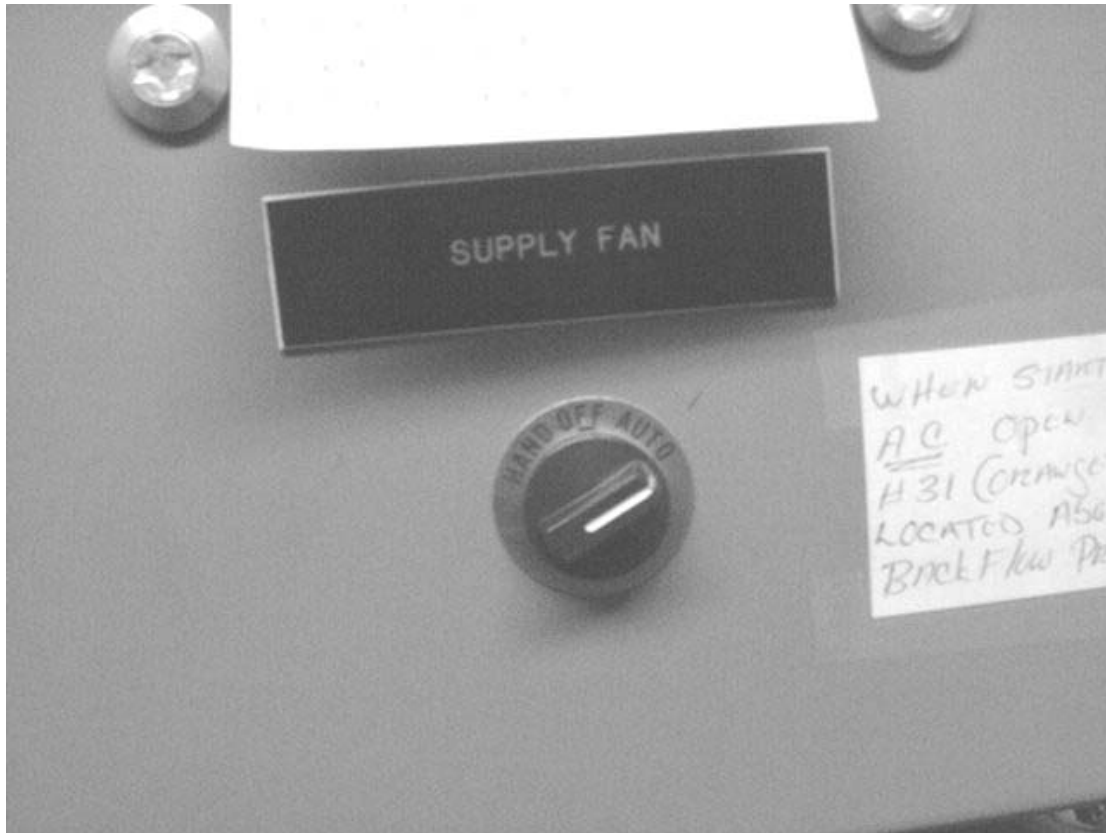
Picture 2

Wall-mounted controls in the mechanical room activate the HVAC system. The control boxes have fan settings of “hand” (on) and “auto” (see Picture 2). All controls were set to the “auto” setting during the assessment. The automatic setting activates the HVAC system at a preset temperature. Once the thermostat reaches a preset temperature, the HVAC system is deactivated until the temperature drops below the heating set point. Therefore, no mechanical ventilation is provided until the thermostat re-activates the system. Little or no airflow was detected from supply or return vents in many areas

during the assessment. Without dilution and removal by the HVAC system, pollutants can build-up in occupied spaces and lead to indoor air quality/complaints.

Supply Fan Control for Ventilation System set to “Auto”

3. To maximize air exchange the BEHA recommends that both supply and exhaust ventilation operate continuously during periods of building occupancy independent of thermostat control (excluding engine bay exhaust system). Consider setting mechanical ventilation controls to the fan "hand" position to provide constant supply and exhaust ventilation.

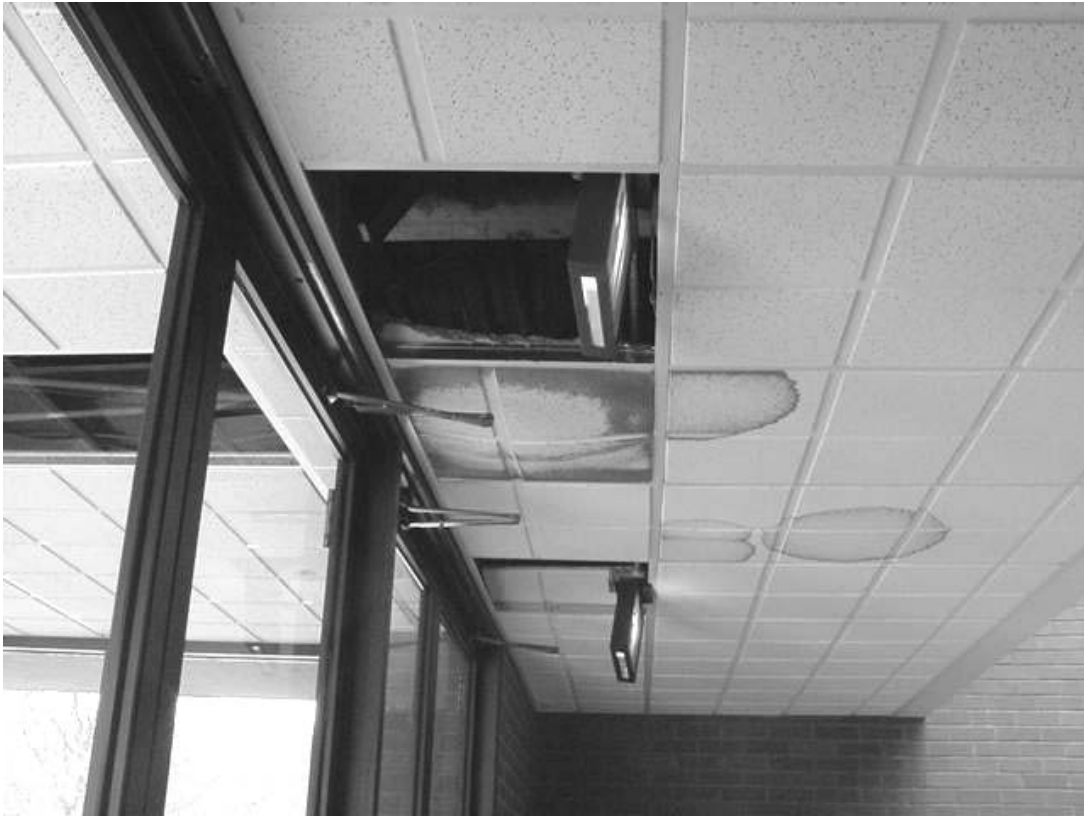
Picture 3

A number of areas had water damaged ceiling tiles (see Table 1). The main entrance appears to be an area of reoccurring water damage (see Picture 3). Water-

damaged ceiling tiles can be a medium for mold growth. The ceiling tiles should be replaced after a water leak is discovered.

Water Damaged Ceiling Tiles in Main Hallway

5. Remove gas-powered equipment from the mechanical room.
6. Repair roof leaks and replace water damaged ceiling tiles.

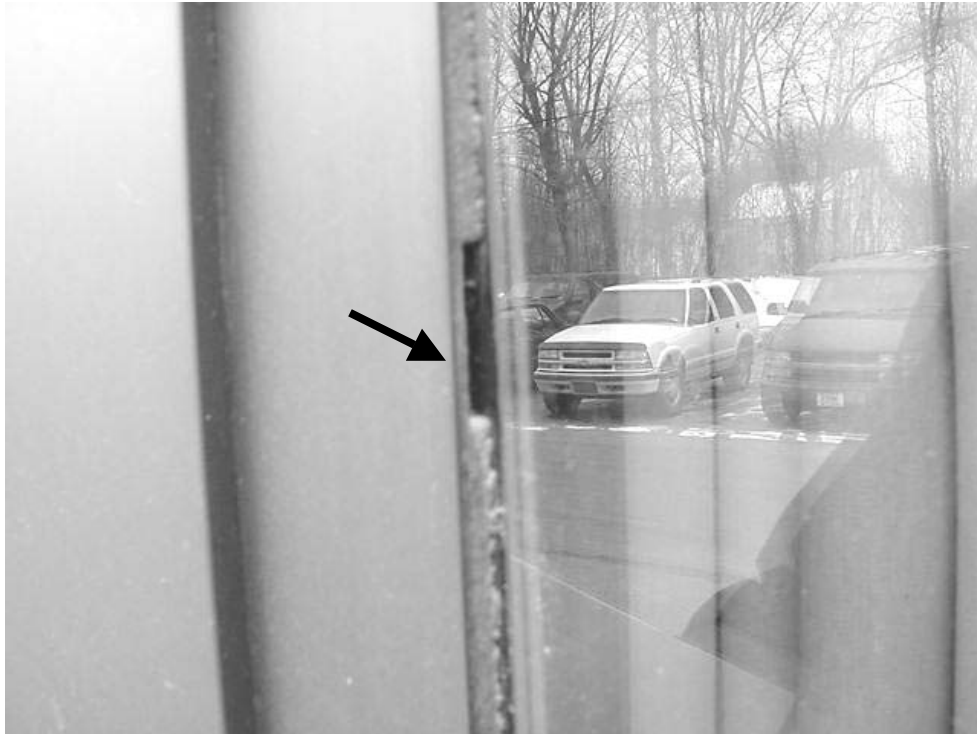
Picture 4

Exterior caulking around windows and frames was crumbling/damaged and spaces were noted around window frames (see Pictures 4-6). Replacement of caulking and repairs of window leaks are necessary to prevent water penetration and subsequent damage to building materials, which can lead to mold growth.

Missing/Damaged Window Caulking (Senior Center)

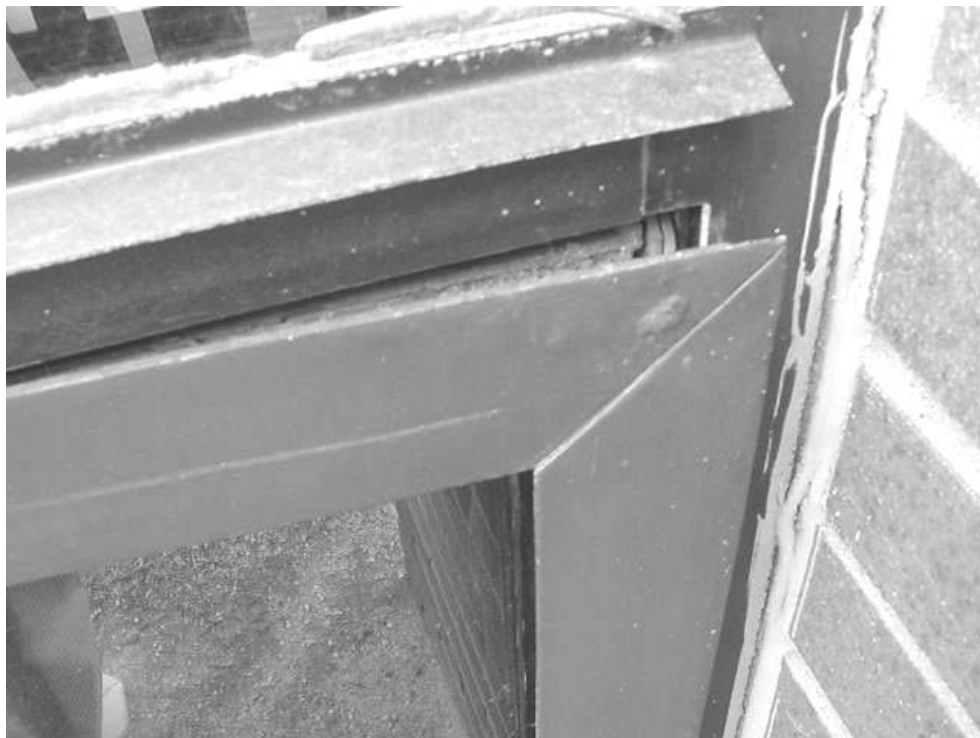
Picture 5

Damaged Window (Senior Center)

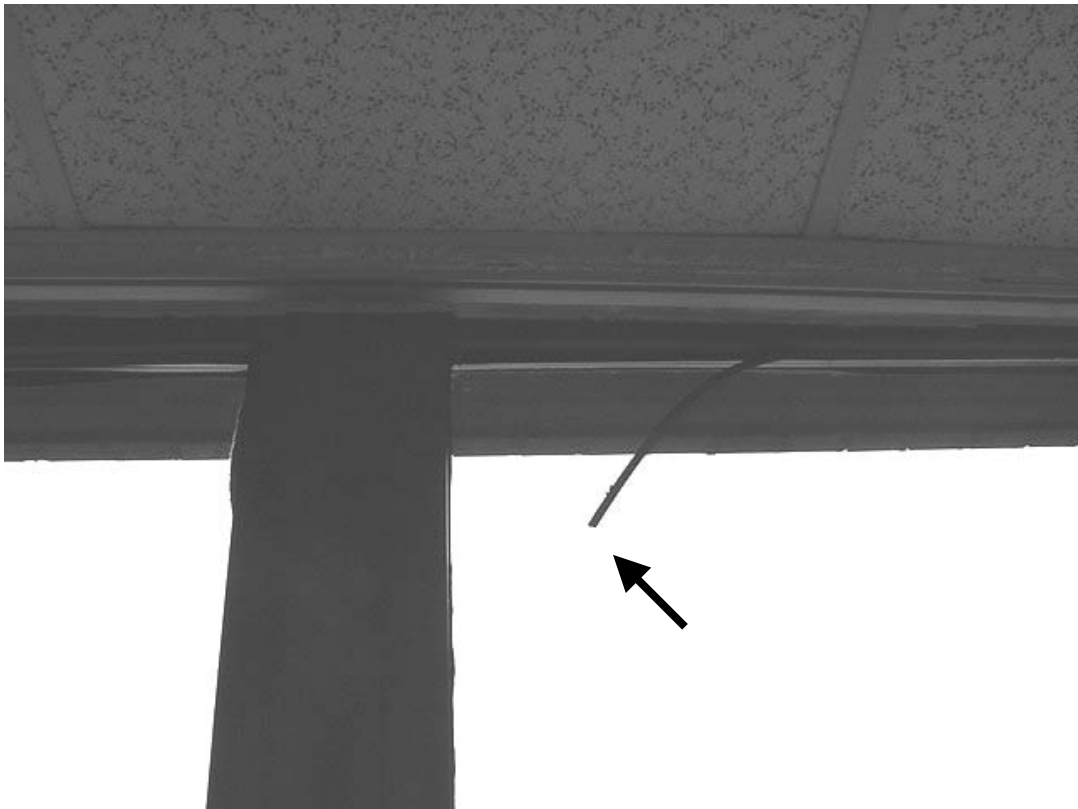
Picture 6

Damaged/Missing Window Seal

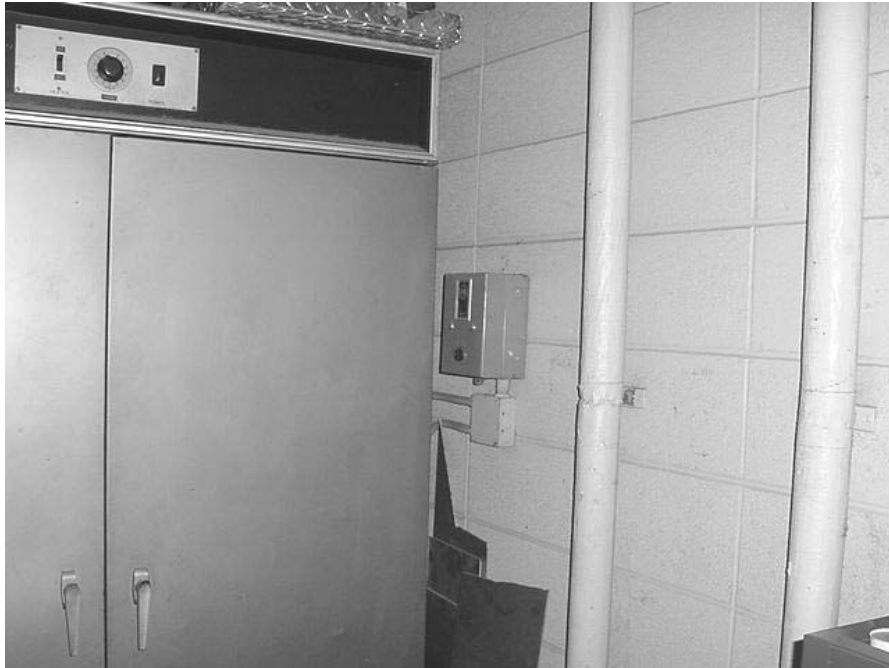
Picture 7

Another potential source of vehicle exhaust emissions in the building are fire-fighting apparatus located in the engine bay of the BFD. Although the station is equipped with a mechanical exhaust system to remove exhaust from the engine bays during vehicle idling, the system has to be manually activated. The activation switch is located on a wall to the rear of the engine bay behind a large piece of equipment (see Picture 7). Due to the location and configuration of the system, it is unlikely that the system is used

routinely, allowing pollutants to build-up in the engine bay and migrate to occupied areas of the building. Several pathways exist for pollutants to enter occupied areas of the building, including spaces beneath engine bay doors and utility holes (see Picture 8).

Wall-Mounted Activation Switch for the Engine Bay Exhaust System

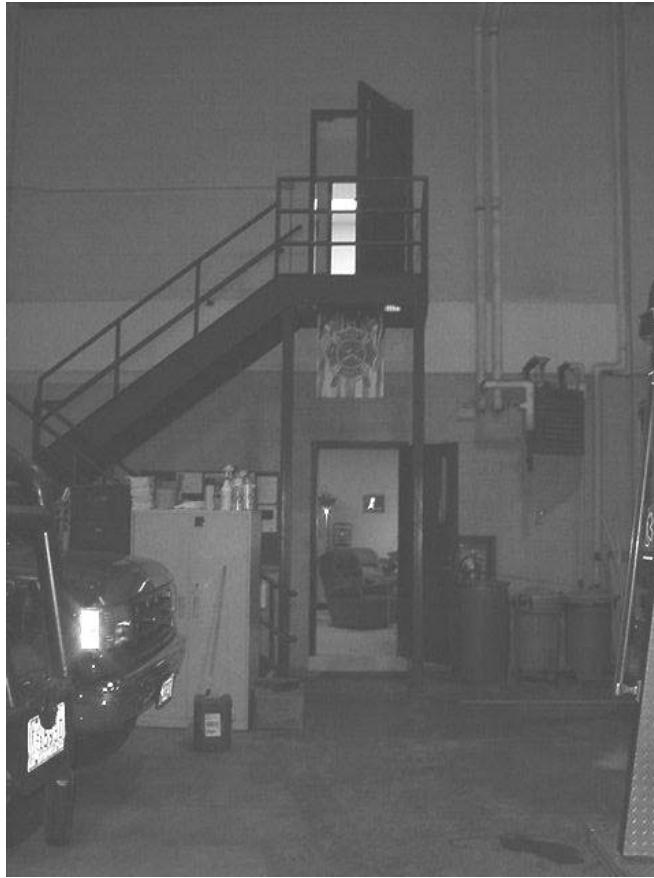
Picture 8

Engine Bay Doors (Upper and Lower) That Open into Occupied Areas

8. Keep all doors accessing engine bays closed at all times. Install weather stripping/door sweeps around doors to prevent exhaust fume migration into occupied areas.

9. Consider replacing engine bay doors or have them repaired to eliminate spaces between doors and frames. Ensure tightness by monitoring for light penetration and drafts around doorframes.

10. Ensure all utility holes are properly sealed in both the engine bay and their terminus to eliminate pollutant paths of migration.
11. Consider contacting the BEHA 's ER/IAQ program to conduct a more thorough IAQ assessment of the Blackstone Fire Department facilities.

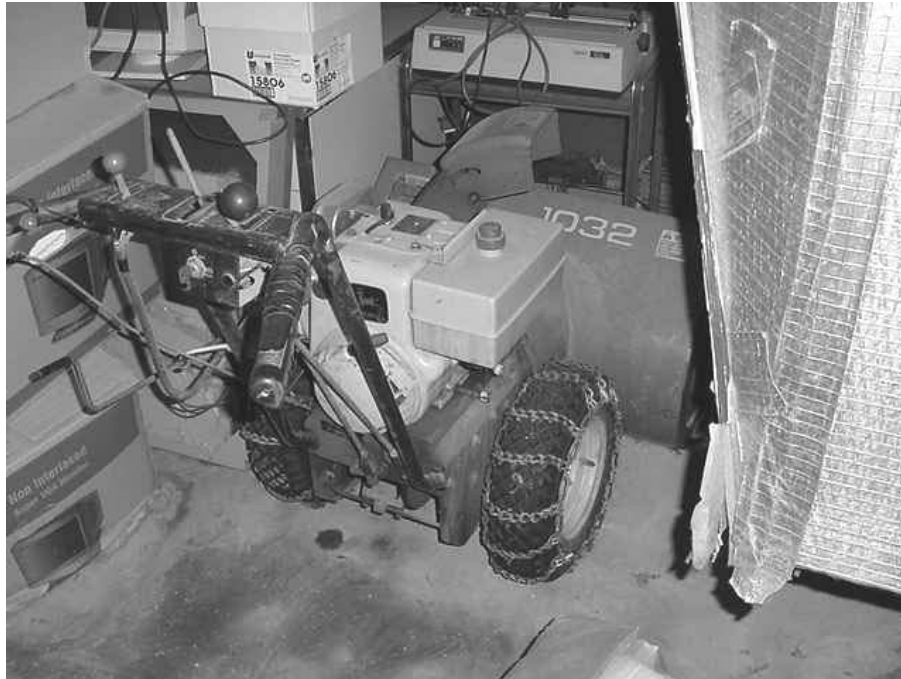
Picture 9

A gas-powered snow blower was observed in the mechanical room approximately five feet from the AHU (see Picture 9). Fuel (e.g. gasoline) is a mixture that contains volatile organic compounds (VOCs) that can be irritating to the eyes, nose and throat. Residual amounts of gasoline can off-gas from this type of equipment, which can result in VOCs being introduced into the ventilation system. Gasoline containing equipment should be stored outside or in an area with continuous local exhaust ventilation to prevent the build-up of flammable vapors indoors.

Gas-Powered Snow Blower Stored in Mechanical Room Near AHU

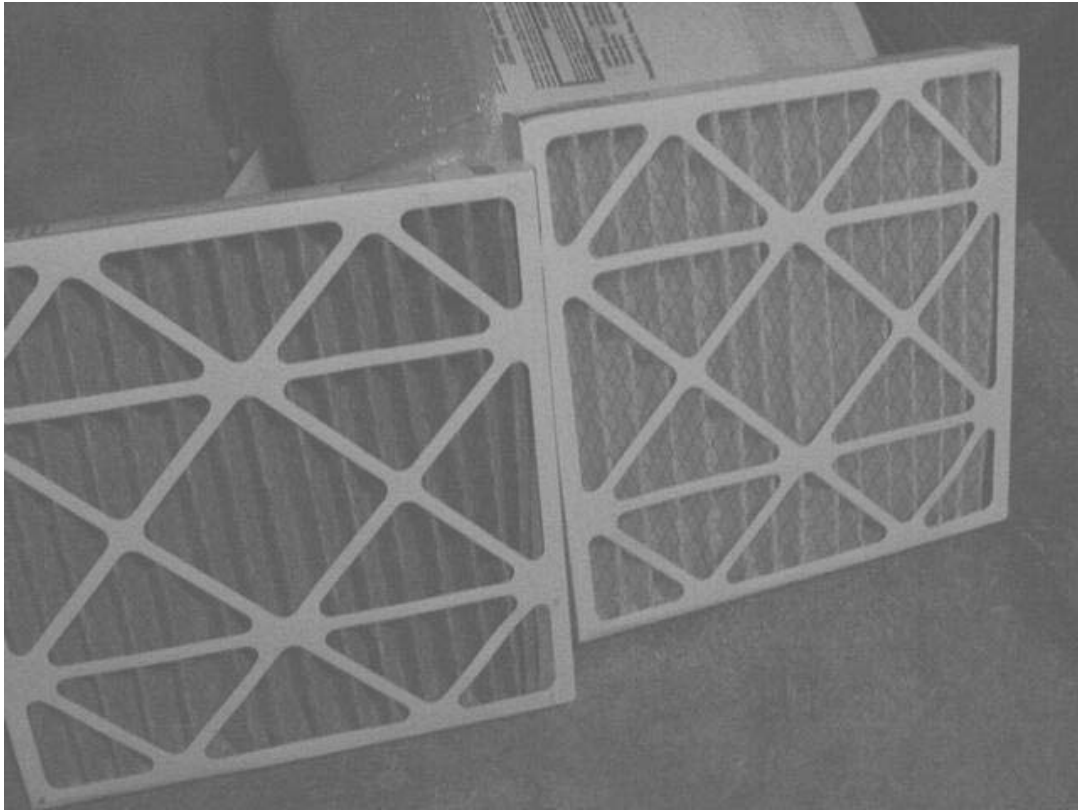
Picture 10

BEHA staff inspected filters for AHUs and found the filters coated with dirt/dust and accumulated material (see Picture 10). A debris-saturated filter can obstruct airflow and may serve as a reservoir of particulates that can be re-aerosolized and distributed to occupied areas via the ventilation system.

Dirty Filter for AHU on Left, Unused Filter on Right

1. Work with Blackstone town officials to develop a preventative maintenance program for all HVAC equipment building wide.
2. Change filters for HVAC equipment as per the manufacturer's instructions or more frequently if needed. Examine HVAC equipment periodically for maintenance and function.

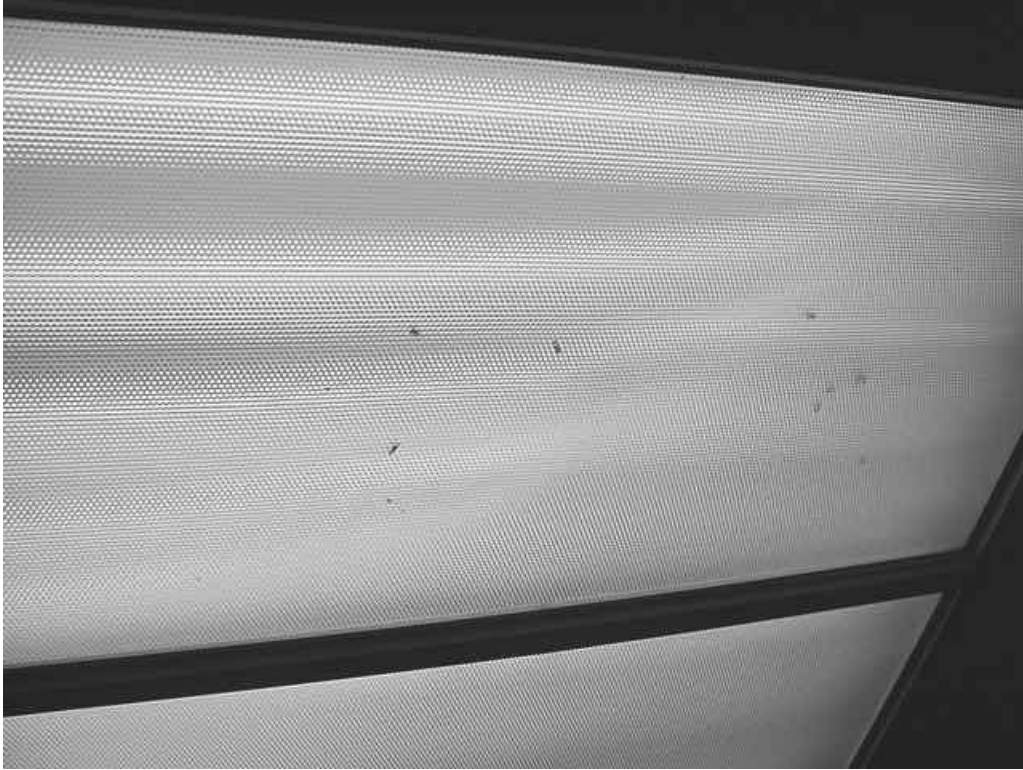
Picture 11

Finally, a number of insect bodies were noted above lighting fixtures in the senior center (see Picture 11). Insect parts can dry and become aerosolized and may serve as a source of allergenic material for sensitive individuals. The most likely route for insect penetration into the building is through spaces around window frames (see Pictures 4 & 5). Once inside the building, insects attracted to light appear to have entered light fixtures through small openings where they became trapped. The reduction/elimination of pathways into the building should be the first step taken to eliminate this infestation.

Insect Bodies Represented by Dark Spots above Lighting Fixtures in Senior Center

13. Use IPM to remove pests from the building. A copy of the IPM recommendations can be downloaded from the Internet at http://www.state.ma.us/dfa/pesticides/publications/IPM_kit_for_bldg_mgrs.pdf.
Activities that can be used to eliminate pest infestation may include the following:

- i) Consult a licensed pesticide applicator on the most appropriate method to end infestation.

- ii) Reduce/eliminate pathways (e.g., spaces under doors)/food sources that are attracting pests.
- iii) Reduce harborages (plants/cardboard boxes) where pests may reside.
